FACE VALUE

BEAUTY 'RESTORED'
at Hilton Pearl River

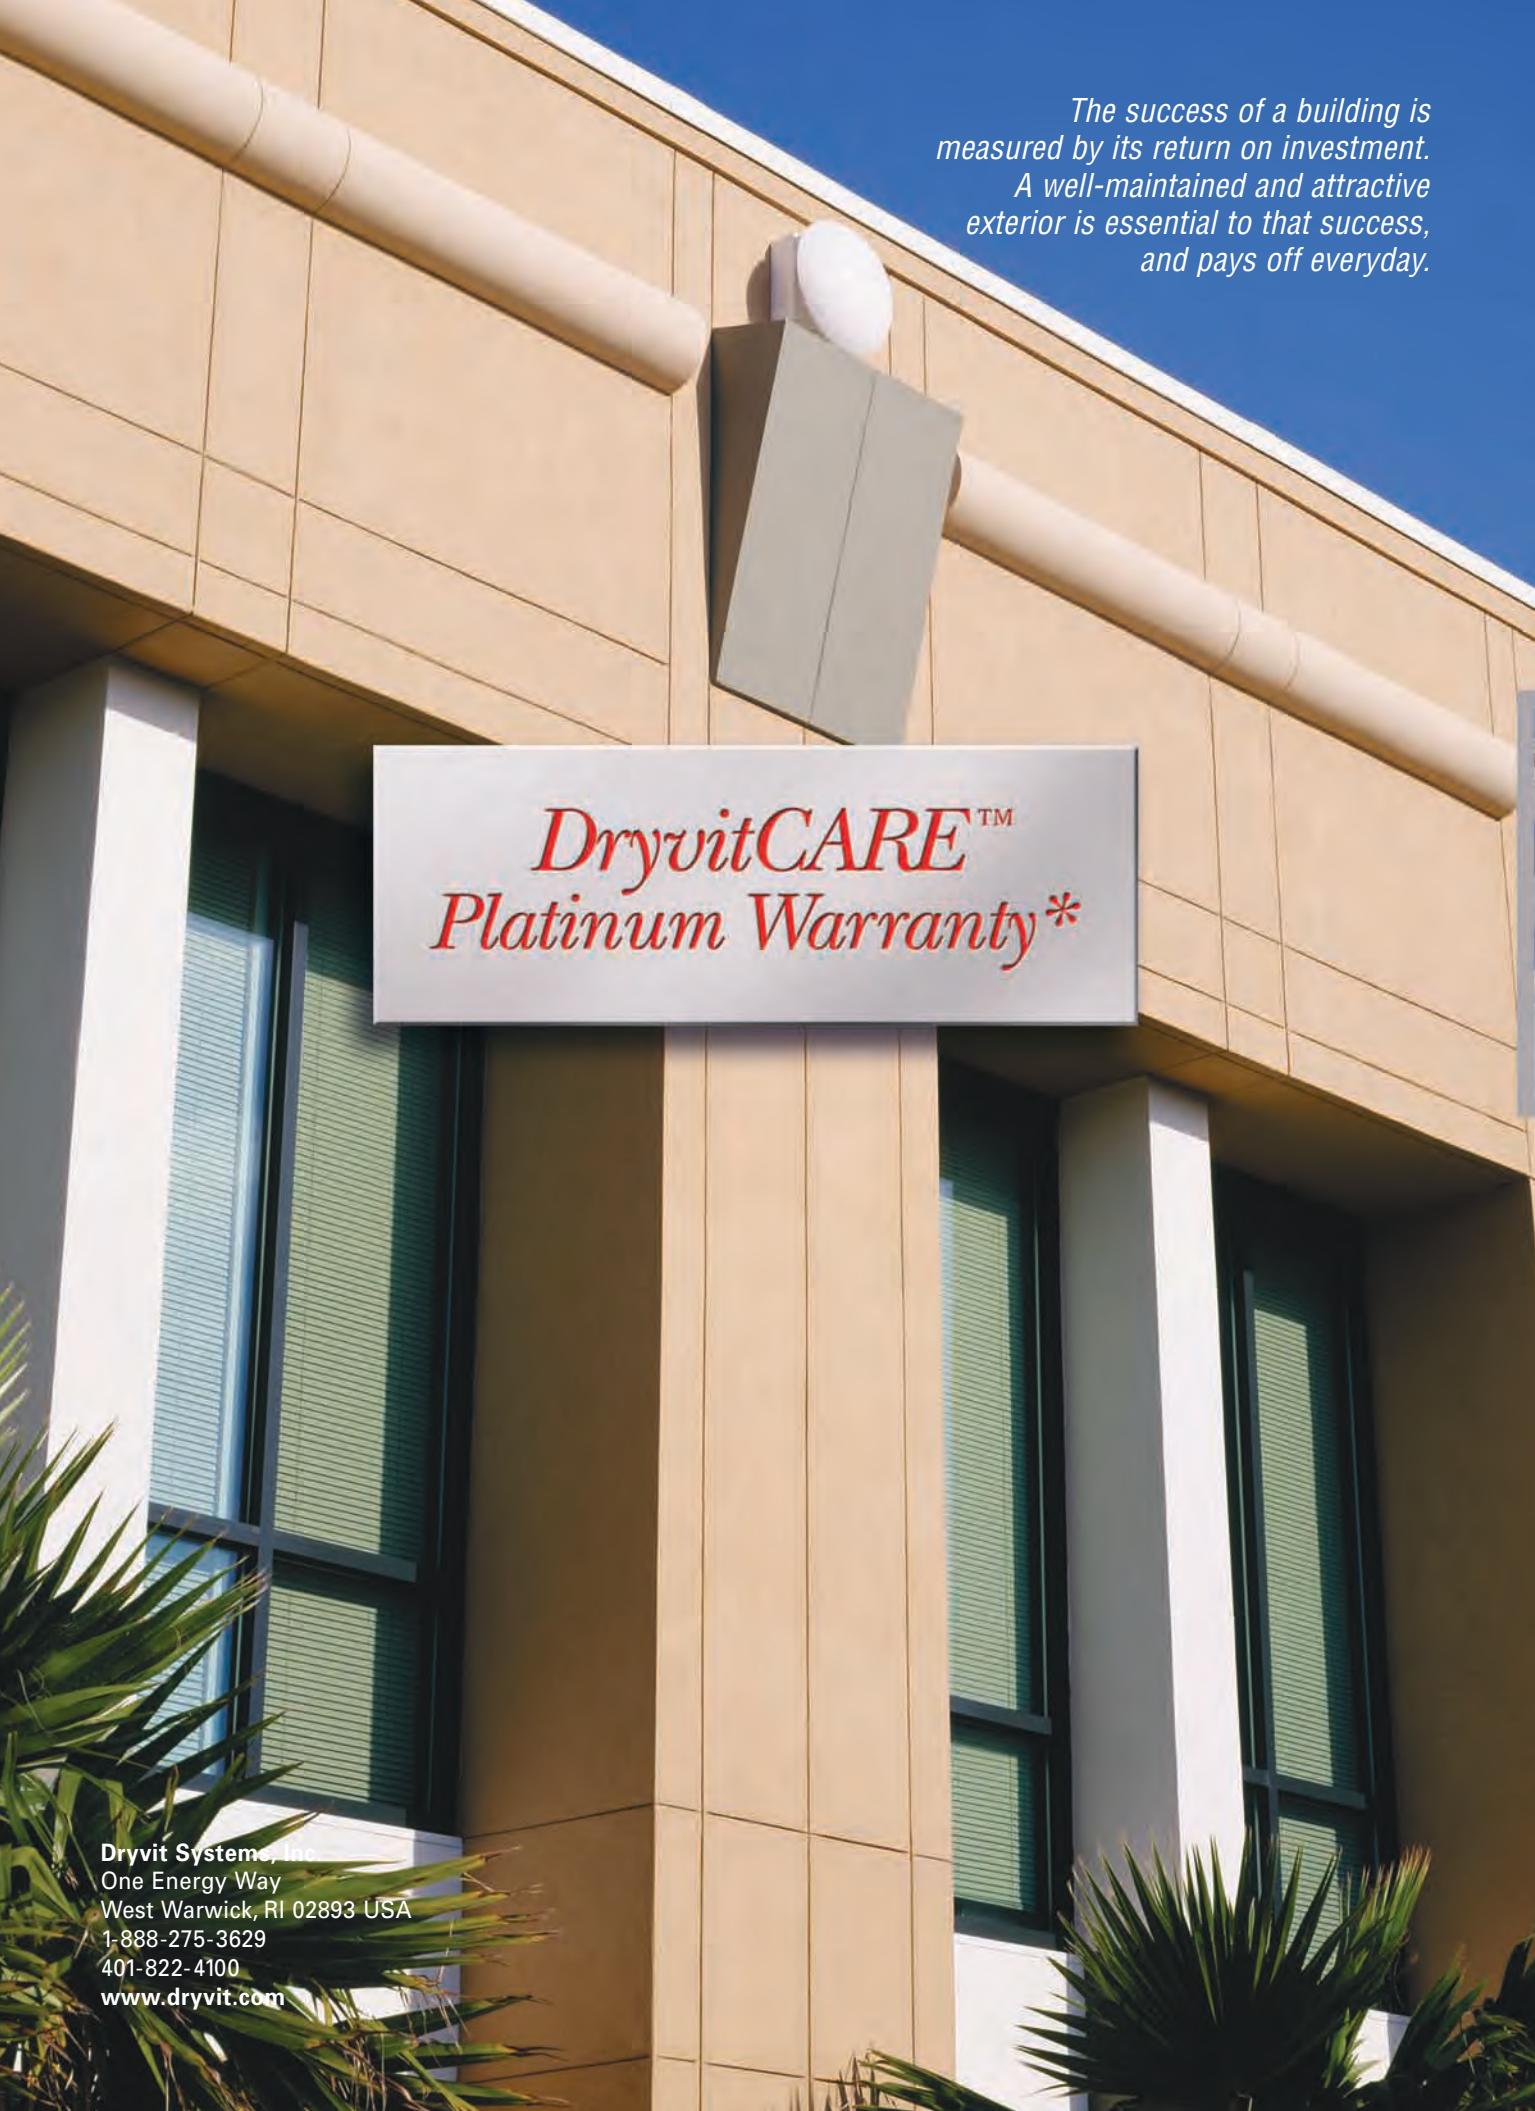
*The success of a building is
measured by its return on investment.
A well-maintained and attractive
exterior is essential to that success,
and pays off everyday.*

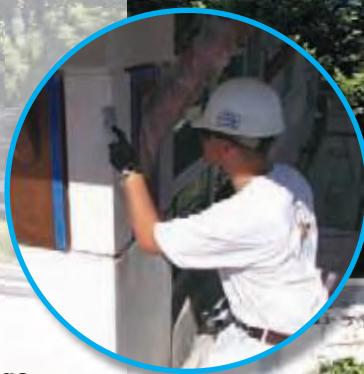
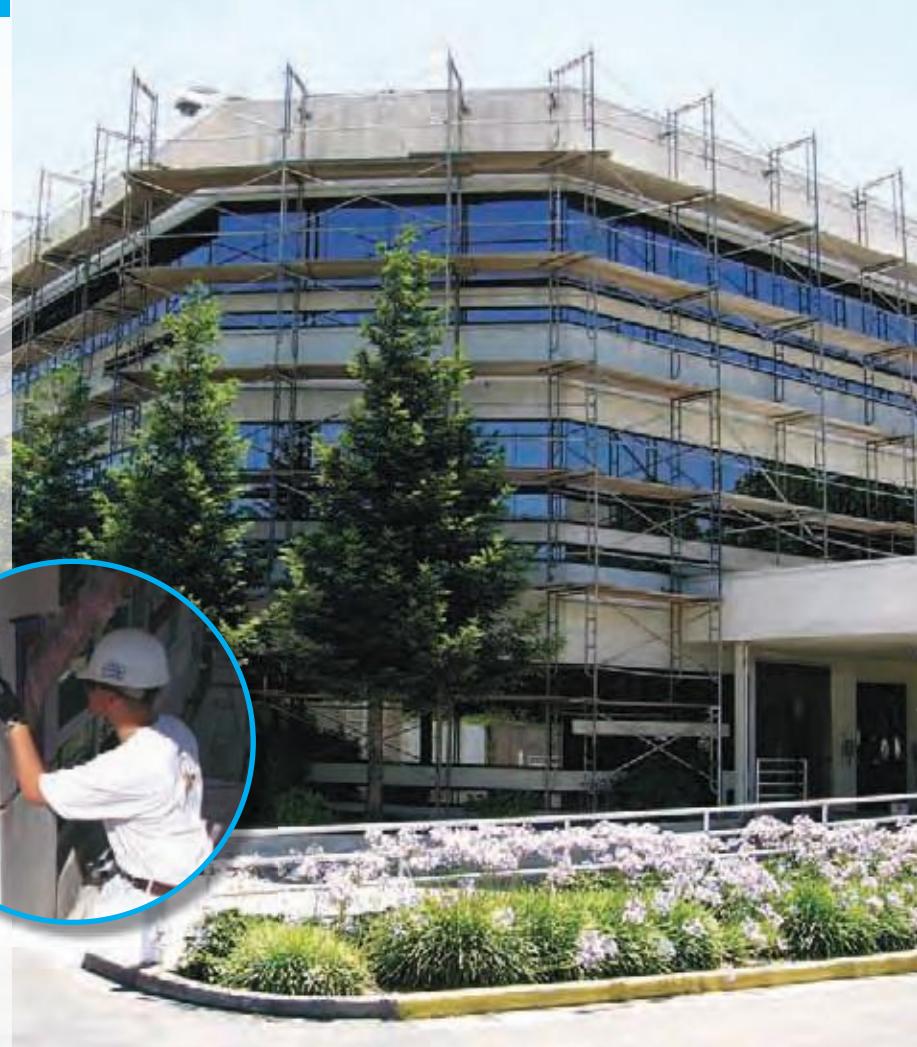
Western specializes in EIFS restoration!

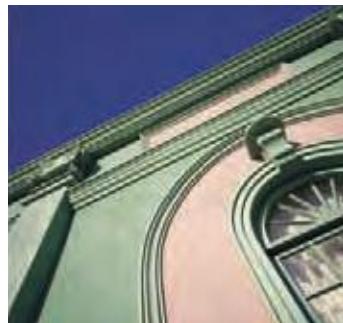
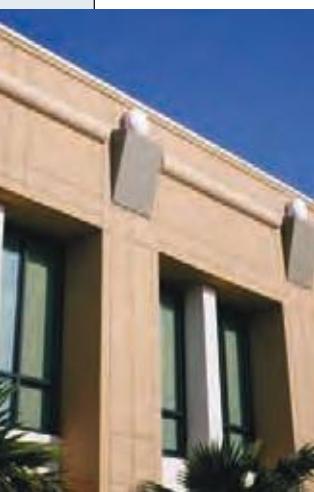
After completing inspections on an EIFS façade, the determination to repair or reclad ultimately comes down to how much EIFS will require removal during the repair process in order to create a functioning, maintainable and aesthetically acceptable façade. During the inspection process, forensic engineers/architects look for signals of cladding distress. The

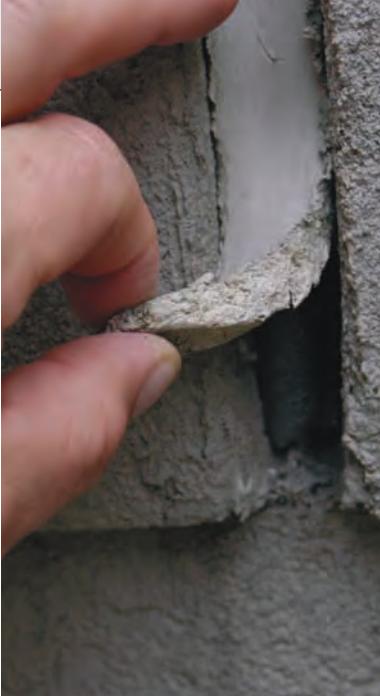
ALL PHOTOS: COURTESY OF DRYVIT SYSTEMS, INC.

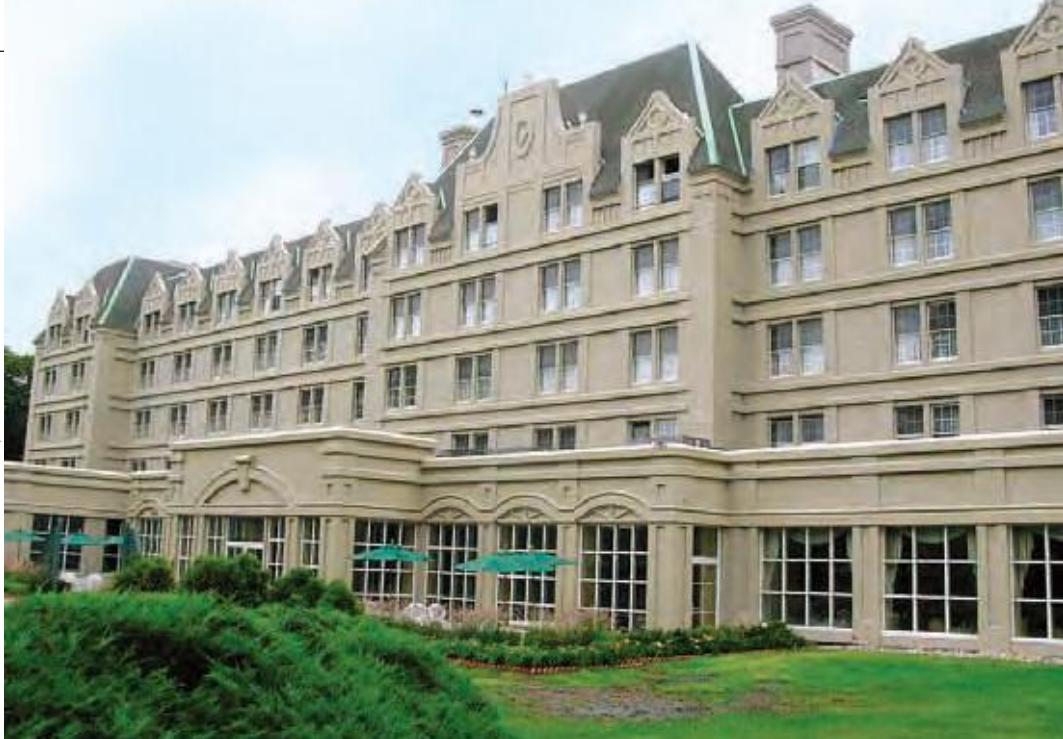
and Gabriel Zitany of Architectural Wall Systems introduced Maloney to the concept of the industry-unique DryvitCARE renewal program, in which an existing Dryvit system can be restored to its original condition or updated using a clearly defined process with 21st-century materials and finishes that may not have been available when the building was first completed. The DryvitCARE concept defines for the building owner the necessary maintenance needed to ensure the long-term performance of an EIFS-clad building. A part of the comprehen-

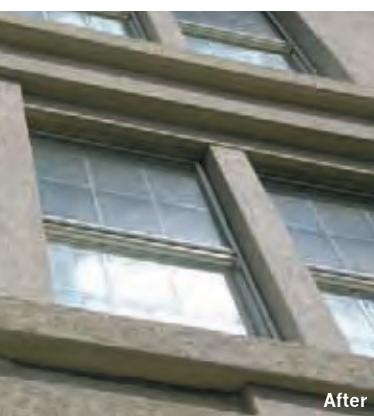
sive package that intrigued Maloney was the program’s Platinum Warranty (essentially, a new warranty for existing buildings clad with Dryvit Outsulation System), which involves independent, third-party building envelope consultants to prescribe the building’s exterior renewal, and results in a new, transferable system warranty for the Dryvit Outsulation System. Mark Colon of Weather-Tite says, “We met with a certified engineer, walked the building and determined areas

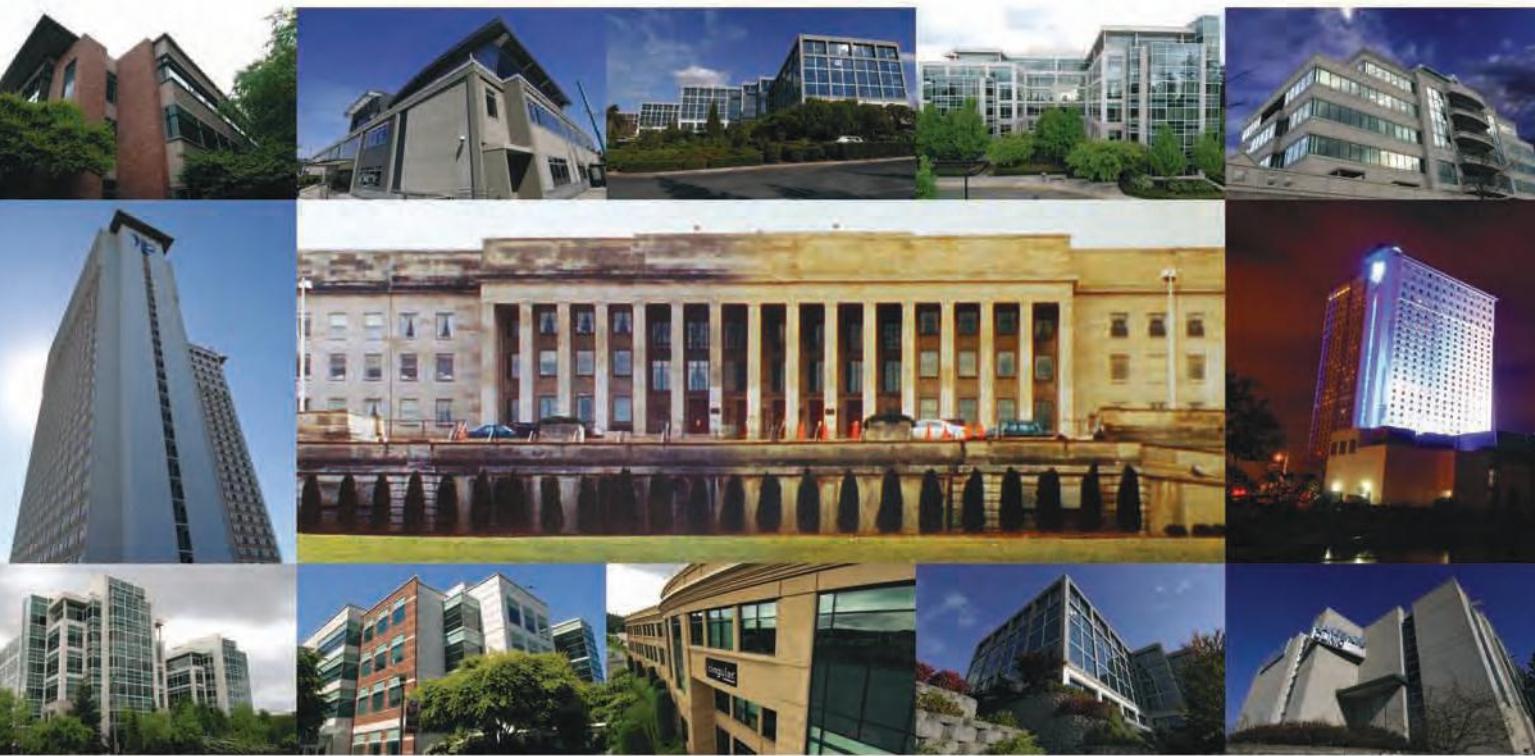
MetroCleanSYSTEMS.COM

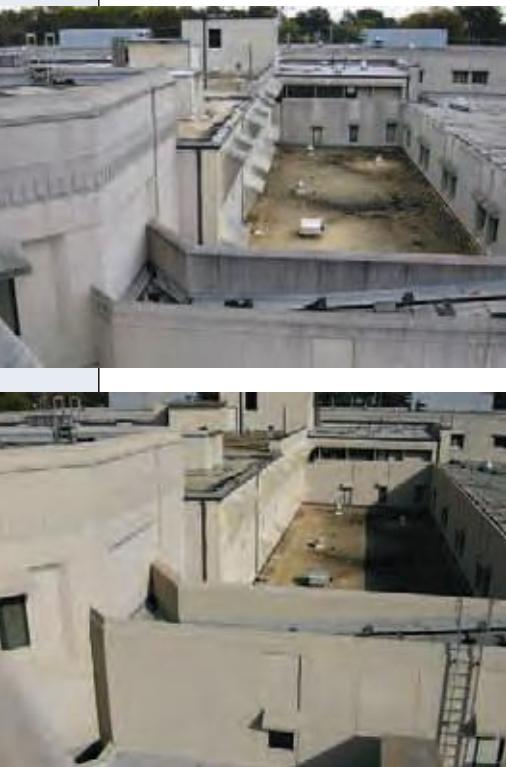
Before and After Cleaning: This building in Athens, AL, is exposed to heat and high humidity, as well as general vehicular traffic.

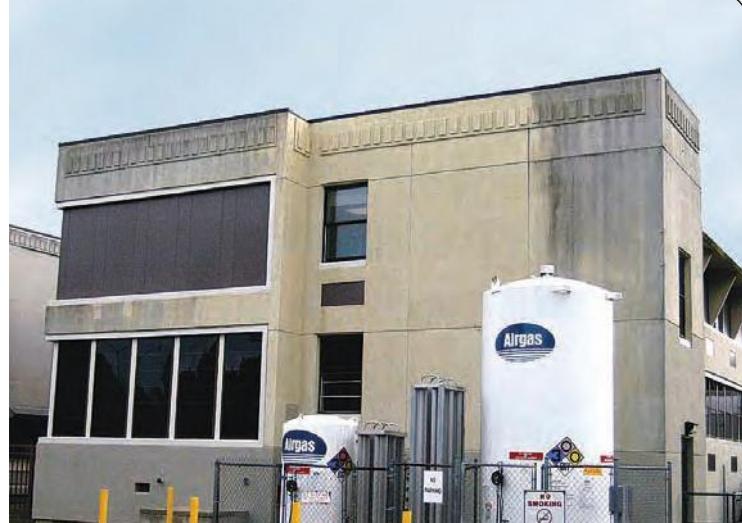
The completed cleaning process (in the central part of this side of the building in Athens, AL) shows the dramatic after results.

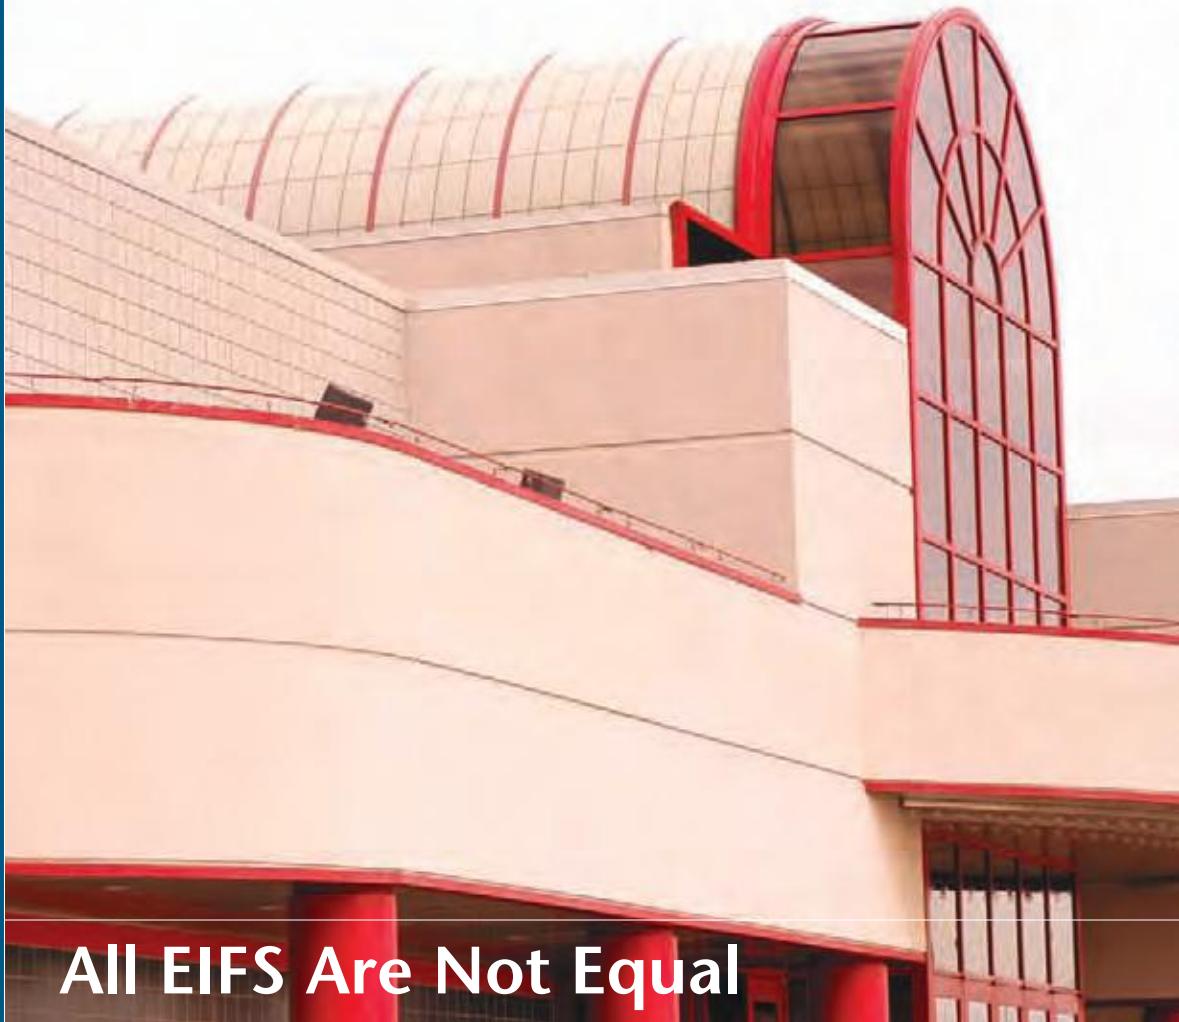
All EIFS Are Not Equal

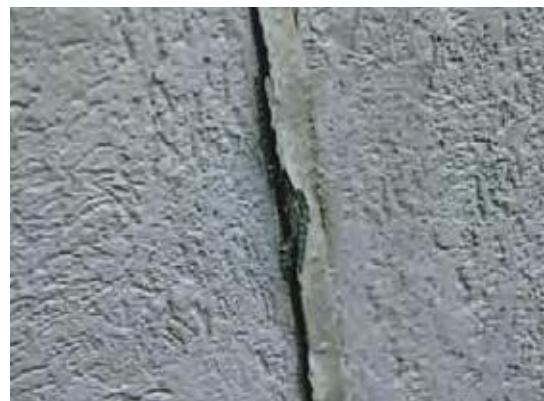
The selection of a sealant that has greater adhesive and cohesive strength than the cohesive strength of the substrate combined with excessive building movement may result in substrate failure where the substrate may become embedded in the sealant surface.

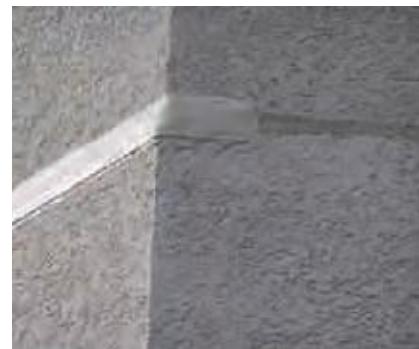
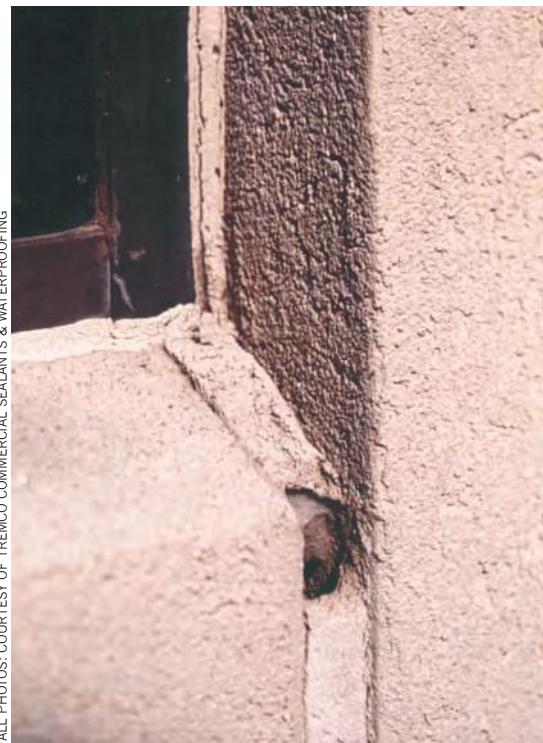
If sealant is installed improperly or the joint movement is greater than the movement capability of the sealant, the potential exists for the sealant to split within itself.

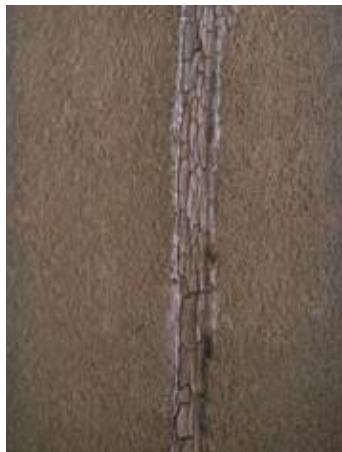
As joint sealants approach the end of their life expectancy, they will begin to show effects of degradation, such as cracking, crazing and oxidation from environmental factors.

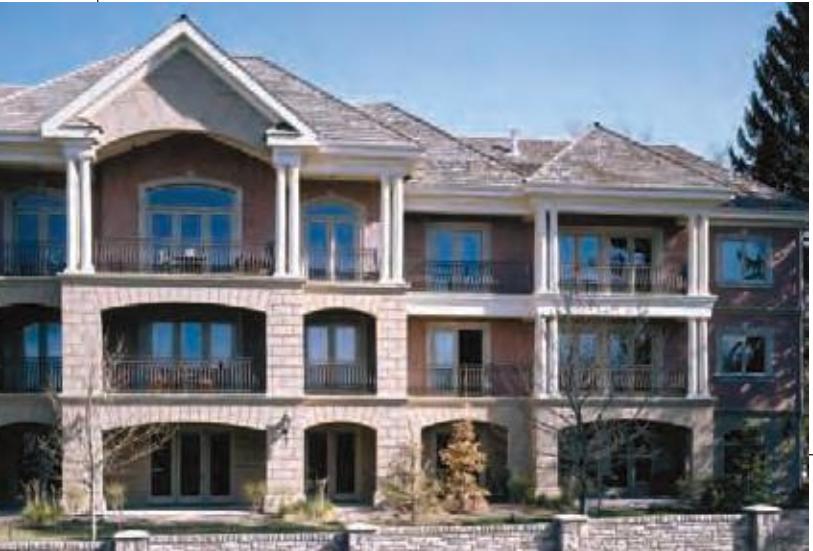
ALL PHOTOS: COURTESY OF DRYVIT SYSTEMS, INC.

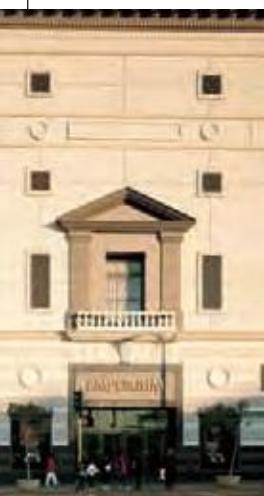
With this in mind, it became imperative for Dryvit to determine whether the production of its Outsulation systems (including the EPS) consumed more energy than the savings gained by using them for the lifetime of a building. Could a Dryvit Outsulation system be a green product in spite of its individual components? What would its overall carbon footprint be as compared with other commonly used claddings? Dryvit asked the National Institute of Standards and Technology (NIST) to answer these questions.

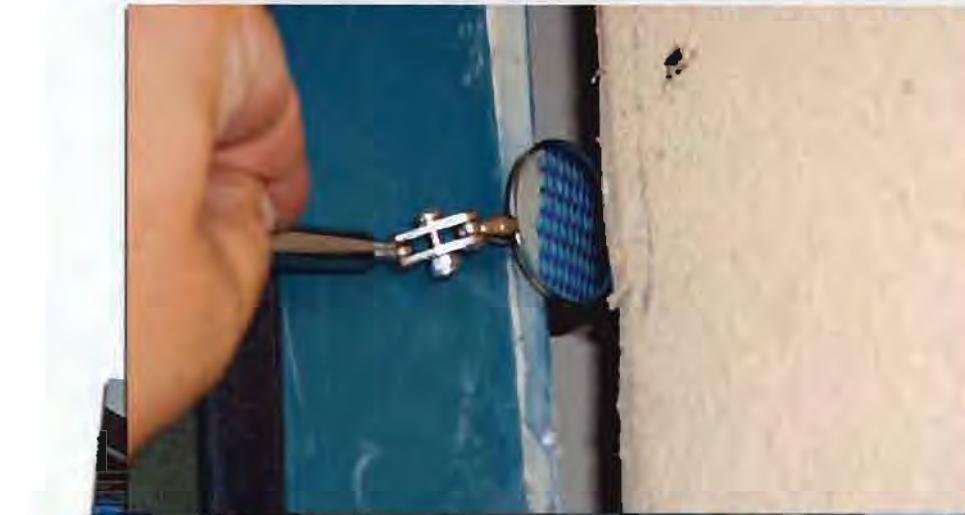
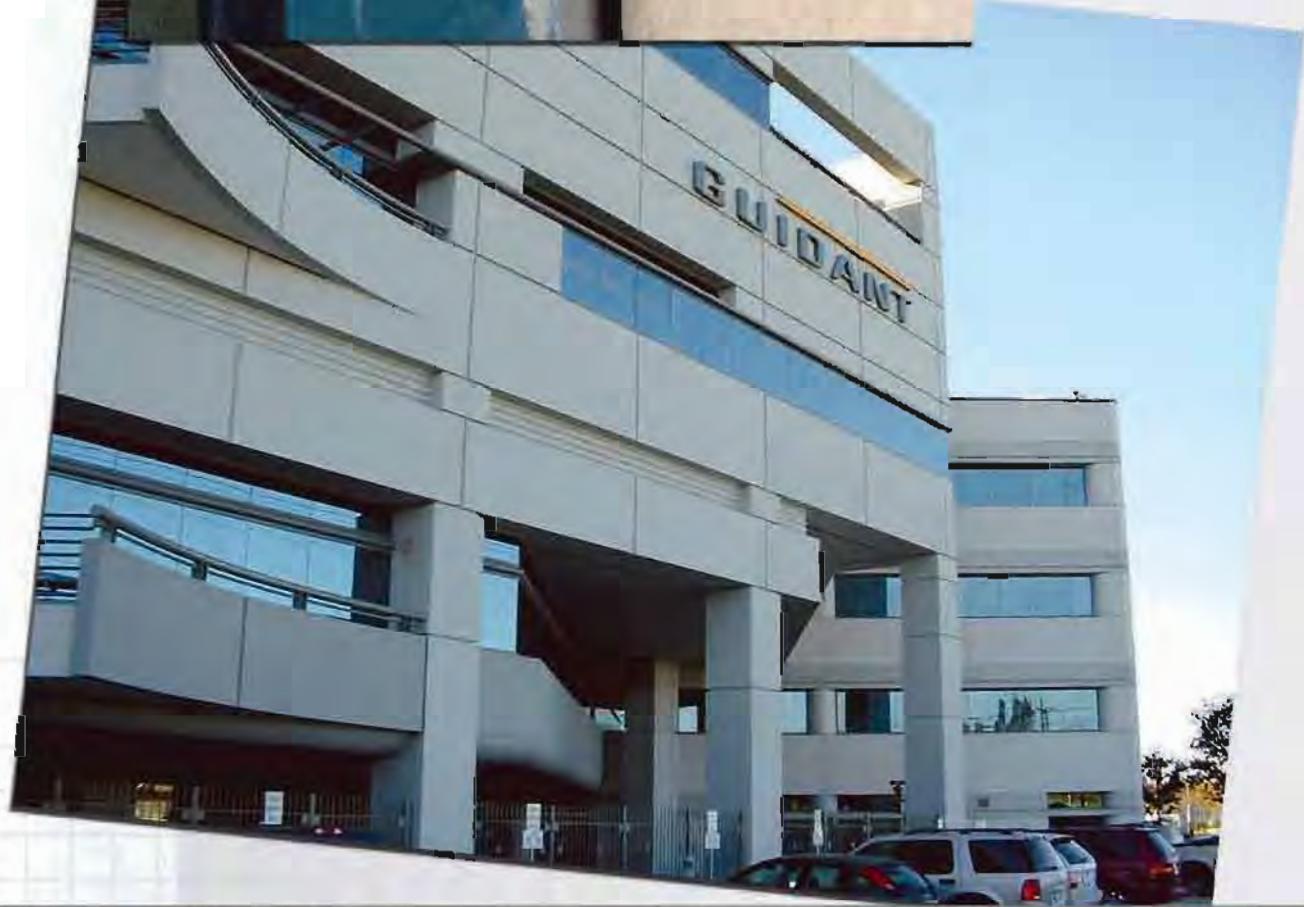
EIFS - Structural Repair & Restoration - Deck Coatings - Caulking - Epoxy Injection - Waterproofing - Stucco Repair
